Revitalizing a century-old architectural landmark

AN EXTENSIVE FACADE REPAIR WAS COMPLETED ON AN ICONIC CHICAGO LANDMARK UTILIZING APPROXIMATELY 400 TONS OF INDIANA LIMESTONE

**LondonHouse Chicago Hotel
facade repair
Chicago, IL**

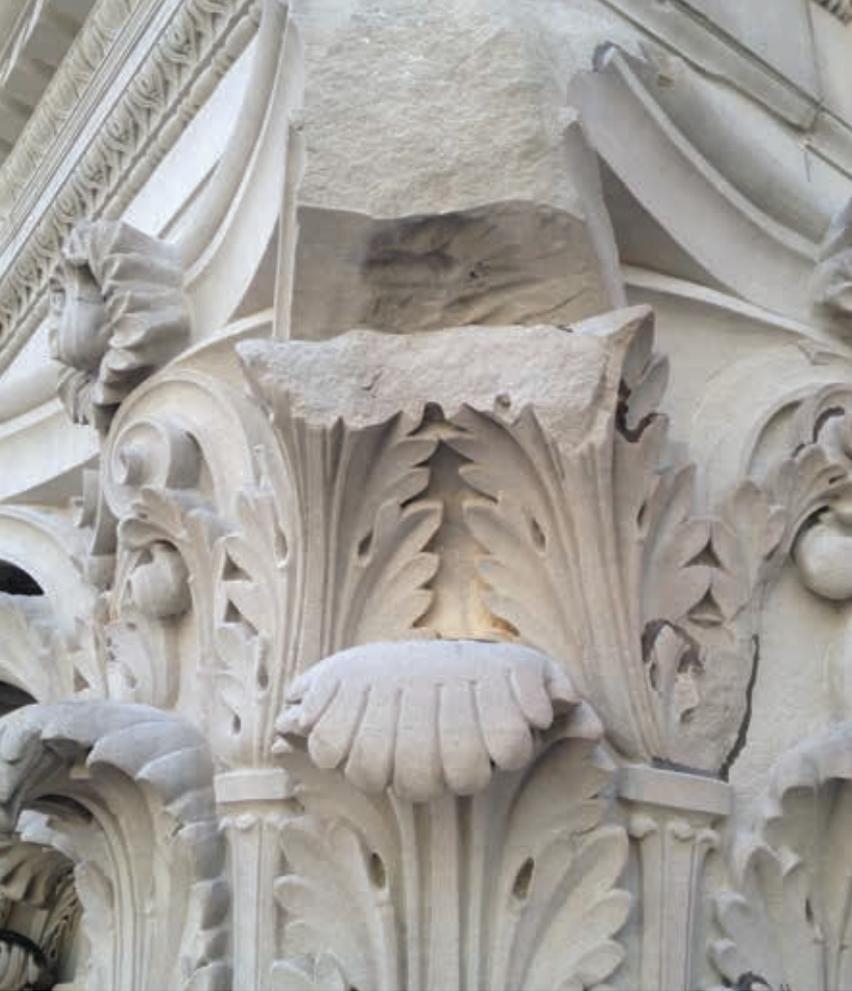
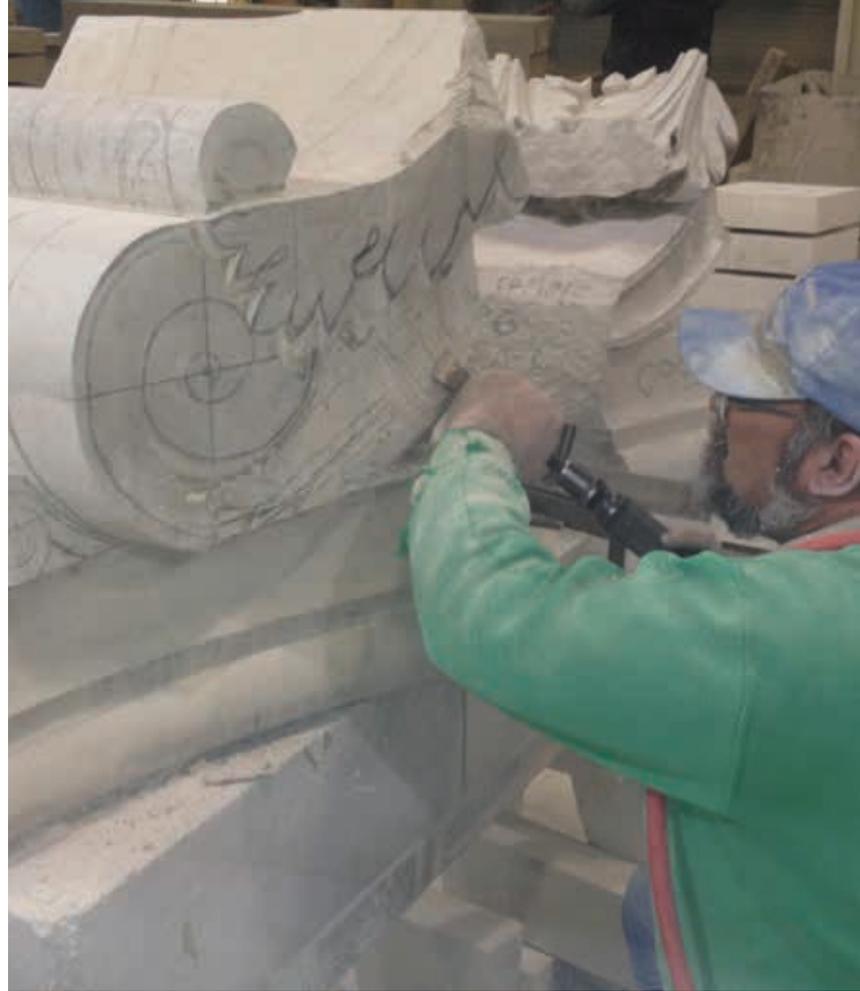
"The most difficult part of the job was matching the large Dutchmen for the fluted columns and carved capitals at the front entrance. We're quite proud of the fact that you cannot differentiate the new stone from the existing." Photo courtesy of Galloy & Van Etten, Inc.

In stone masonry, Dutchmen are stone insets selectively replacing only the fault in stone with new or reused stone material. The Corinthian column capitals at the building's main entrance were damaged and missing large sections of the acanthus leaves and scrolls, as Van Etten mentions, so ornate Dutchmen were installed and final detailing was hand-carved in-situ to allow for the capitals' elegant details to be matched precisely.

For Van Etten, matching all of the existing profiles and carvings was a difficult process, which required great attention to detail. "In some cases, the stone was so deteriorated that we had to recreate the existing pieces before we could fabricate the new pieces," he explained. "The most difficult part of the job was matching the large Dutchmen for the fluted columns and carved capitals at the front entrance. We're quite proud of the fact that you cannot differentiate the new stone from the existing."

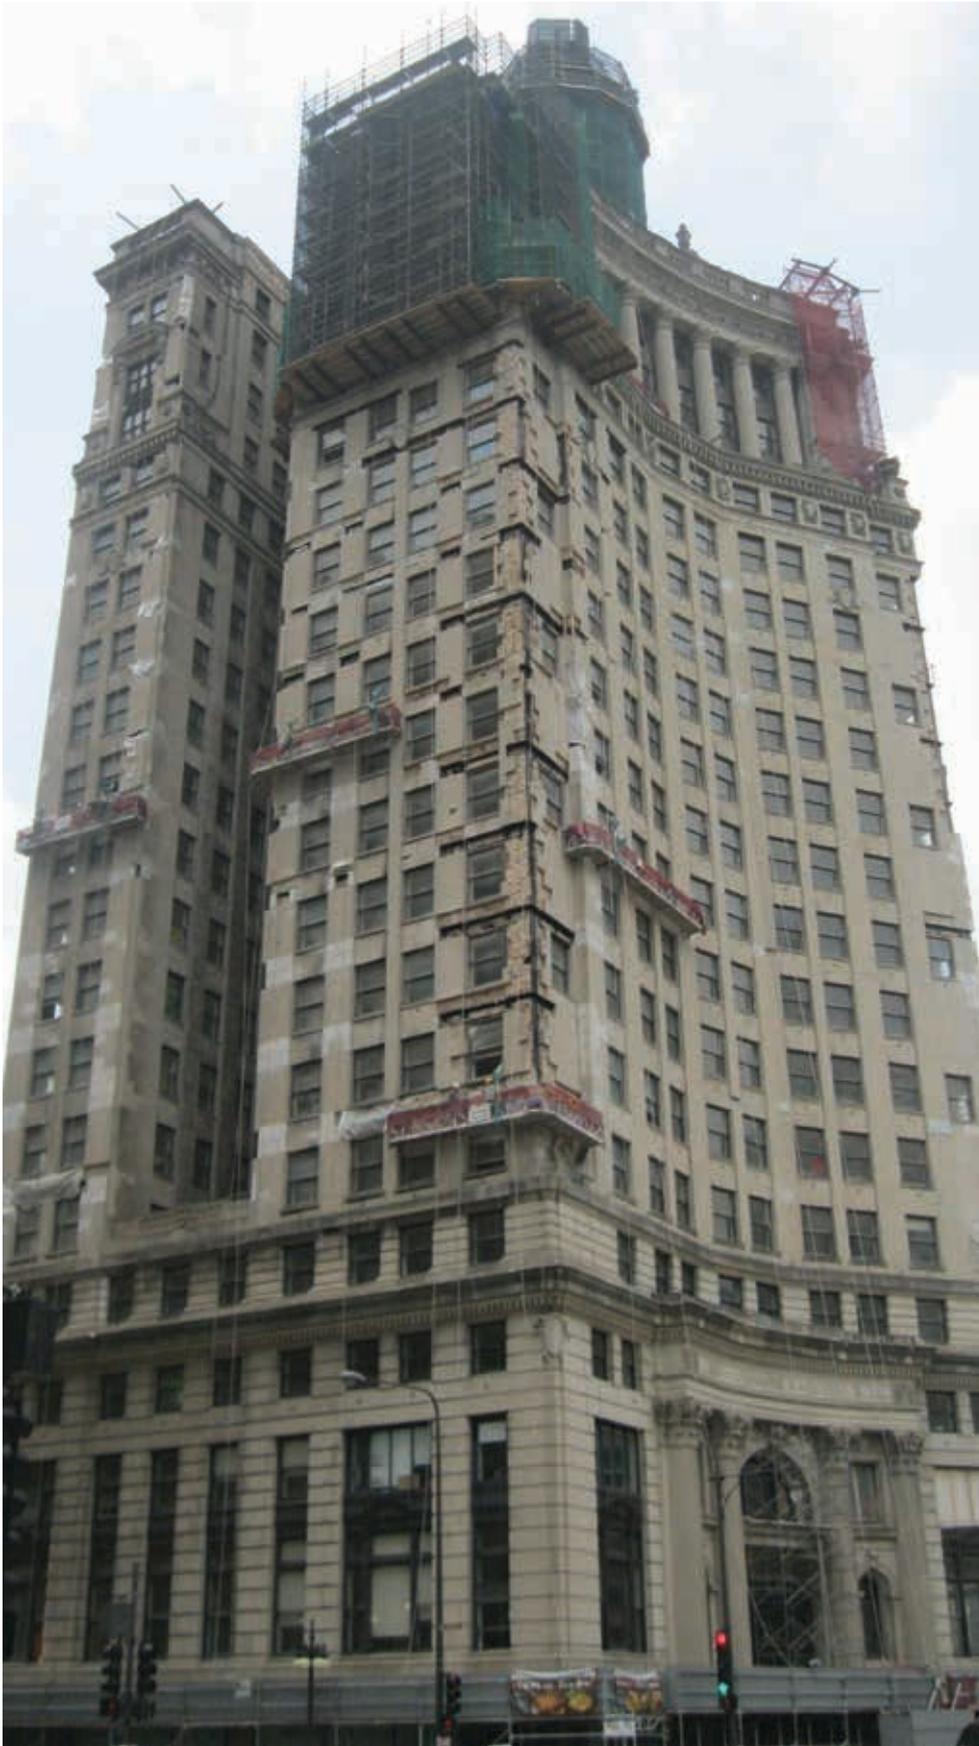
“Ten limestone urns were reset across the rooftop parapet,” Naponelli said. “Each urn weighed approximately 4,000 pounds and required a crane to lift the decorative features. The urns had been removed 15 years prior because of significant outward displacement and concern that they may fall 21 stories to the sidewalks below.”

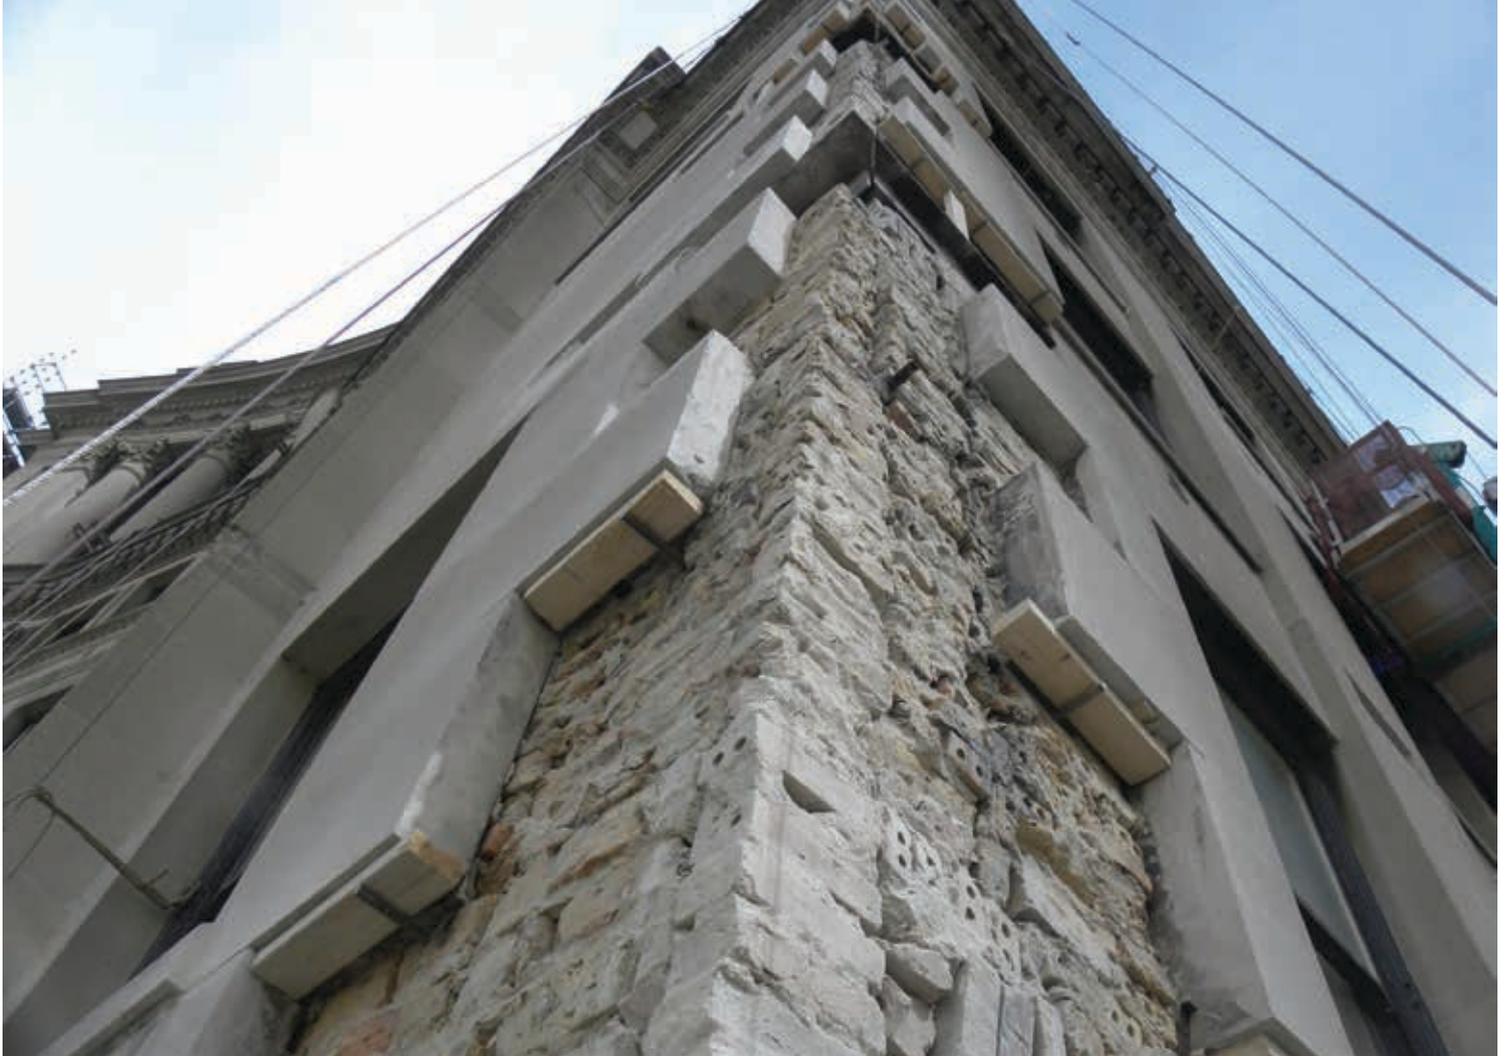
A majority of the work was performed from swing-stage scaffolds, however, the degree of facade repair at the upper floors was so extensive that pipe scaffolding was erected from platforms cantilevered out as a putlog system from the 18th floor windows, allowing for the repairs to be performed. At these locations, entire cornices and belt courses were removed and rebuilt.

A majority of the work was performed from swing-stage scaffolds, however, the degree of facade repair at the upper floors was so extensive that pipe scaffolding was erected from platforms cantilevered out as a putlog system from the 18th floor windows, allowing for the repairs to be performed. Photos courtesy of K&H

"The location of some of these stones presented a challenge in that cranes and hoists had to be used, and pipe scaffolding had to be erected on platforms in order to allow the work to be done safely," said Don Seefeldt, senior executive vice president at Mark 1 Restoration Company in Dolton, IL, which completed the exterior installation. Photo courtesy of K&H

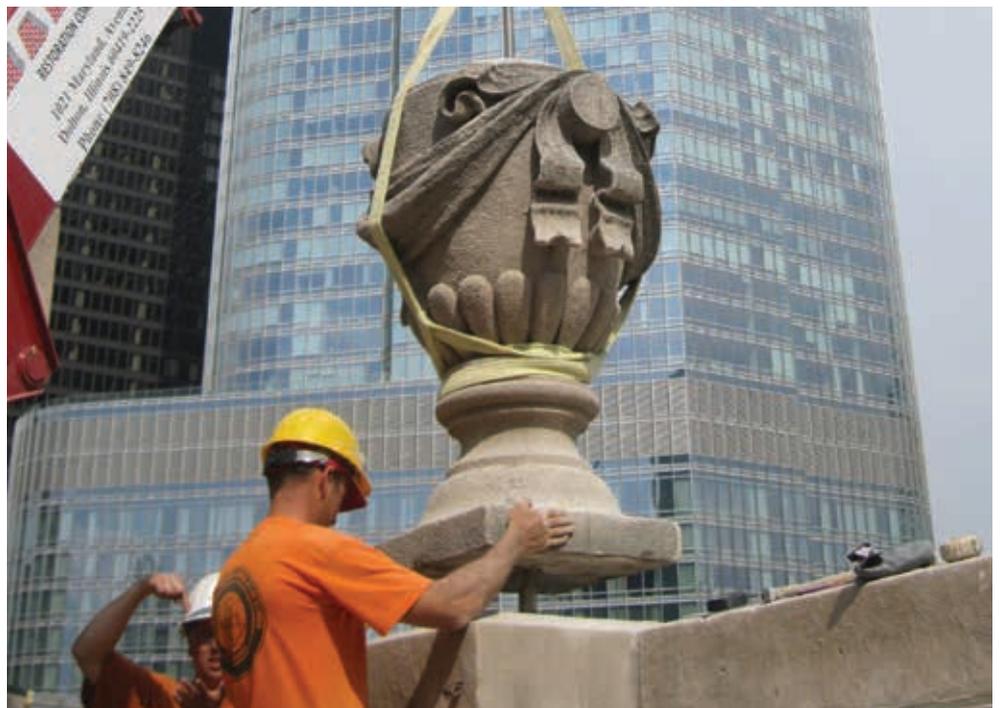
"Ten limestone urns were reset across the rooftop parapet," Naponelli said. "Each urn weighed approximately 4,000 pounds and required a crane to be lifted into place. The urns had been removed 15 years prior because of significant outward displacement and concern that they may fall 21 stories to the sidewalks below." Photo courtesy of K&H
