Revitalizing a century-old architectural landmark

AN EXTENSIVE FACADE REPAIR WAS COMPLETED ON AN ICONIC CHICAGO LANDMARK UTILIZING APPROXIMATELY 400 TONS OF INDIANA LIMESTONE

**LondonHouse Chicago Hotel
facade repair
Chicago, IL**

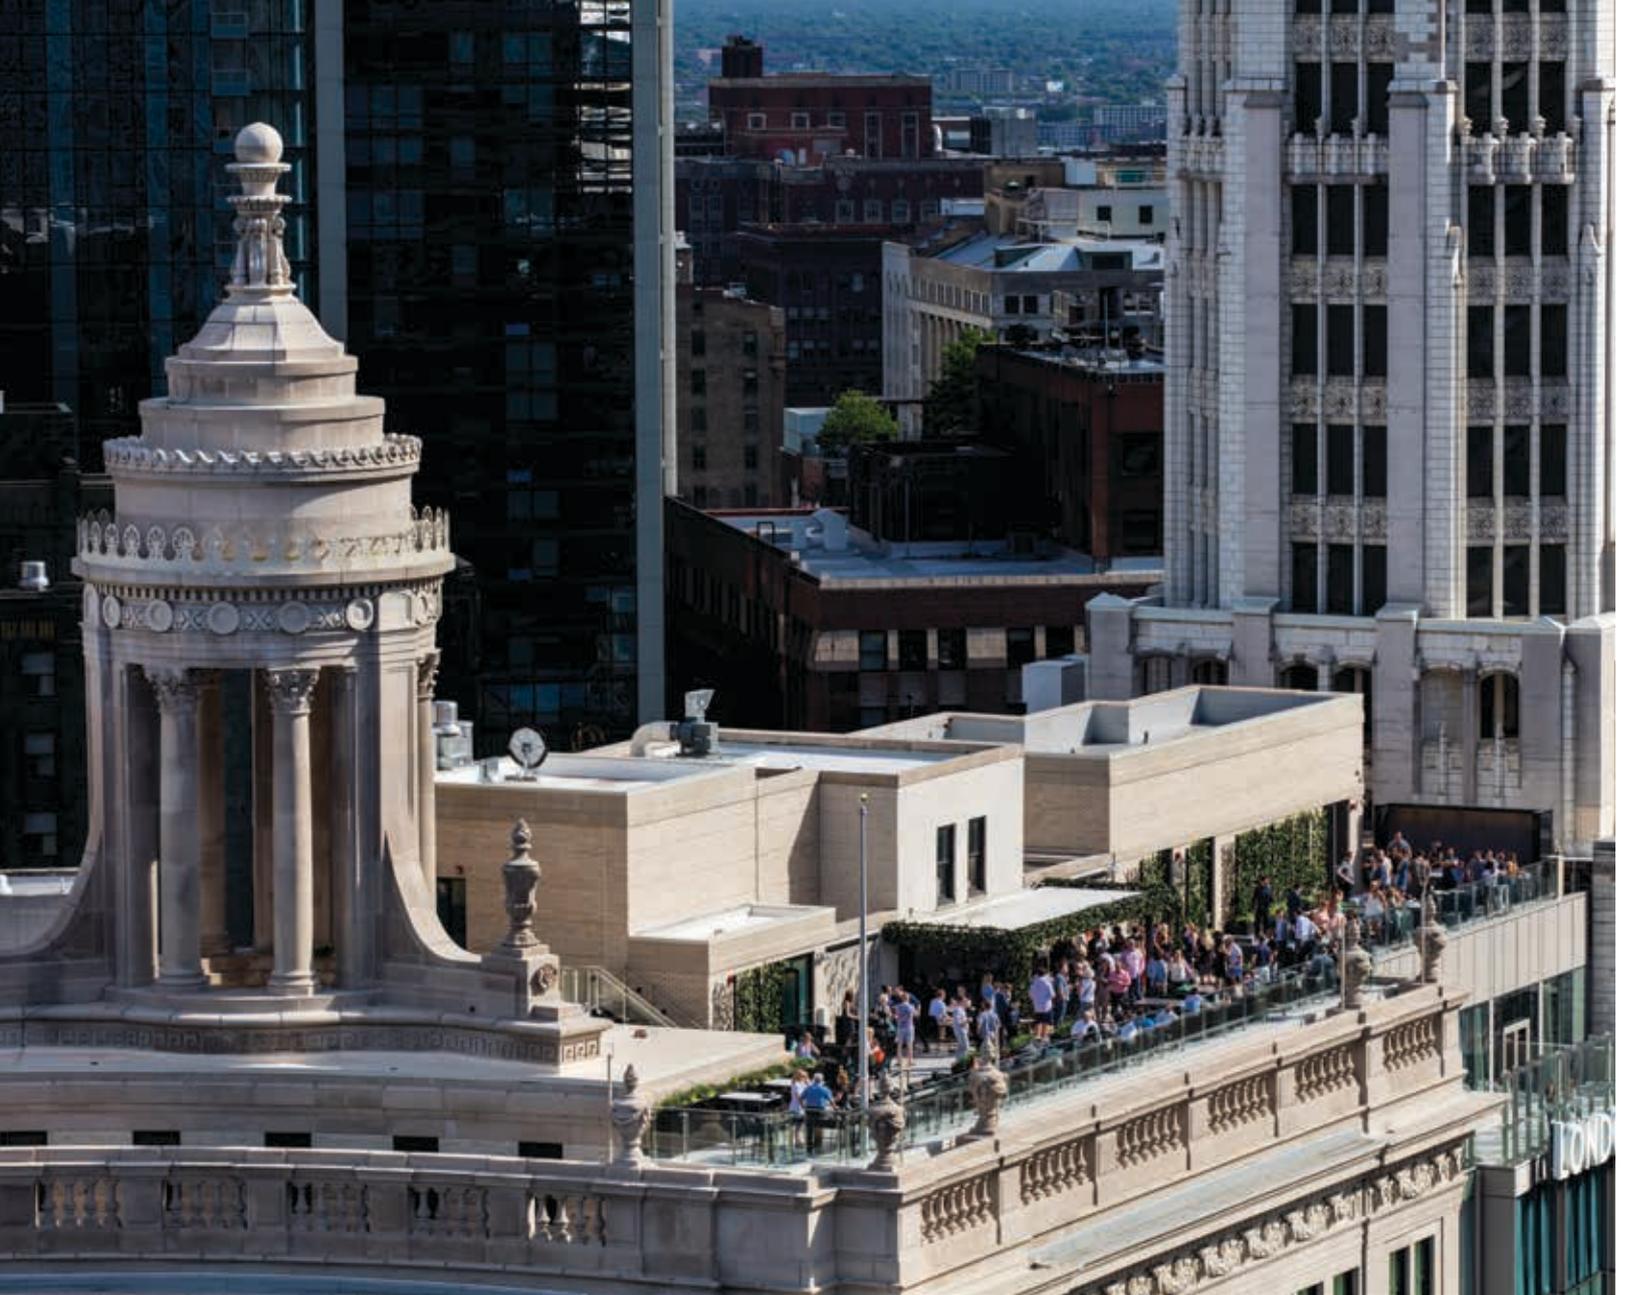
After 91 years of operating as an office building, a skyscraper at the corner of North Michigan Avenue and Wacker Drive in Chicago, IL, was converted to a hotel. The conversion was part of the building's adaptive reuse program, which began in 2014 and was completed in late 2016, creating the LondonHouse Chicago Hotel. Photo courtesy of K&H

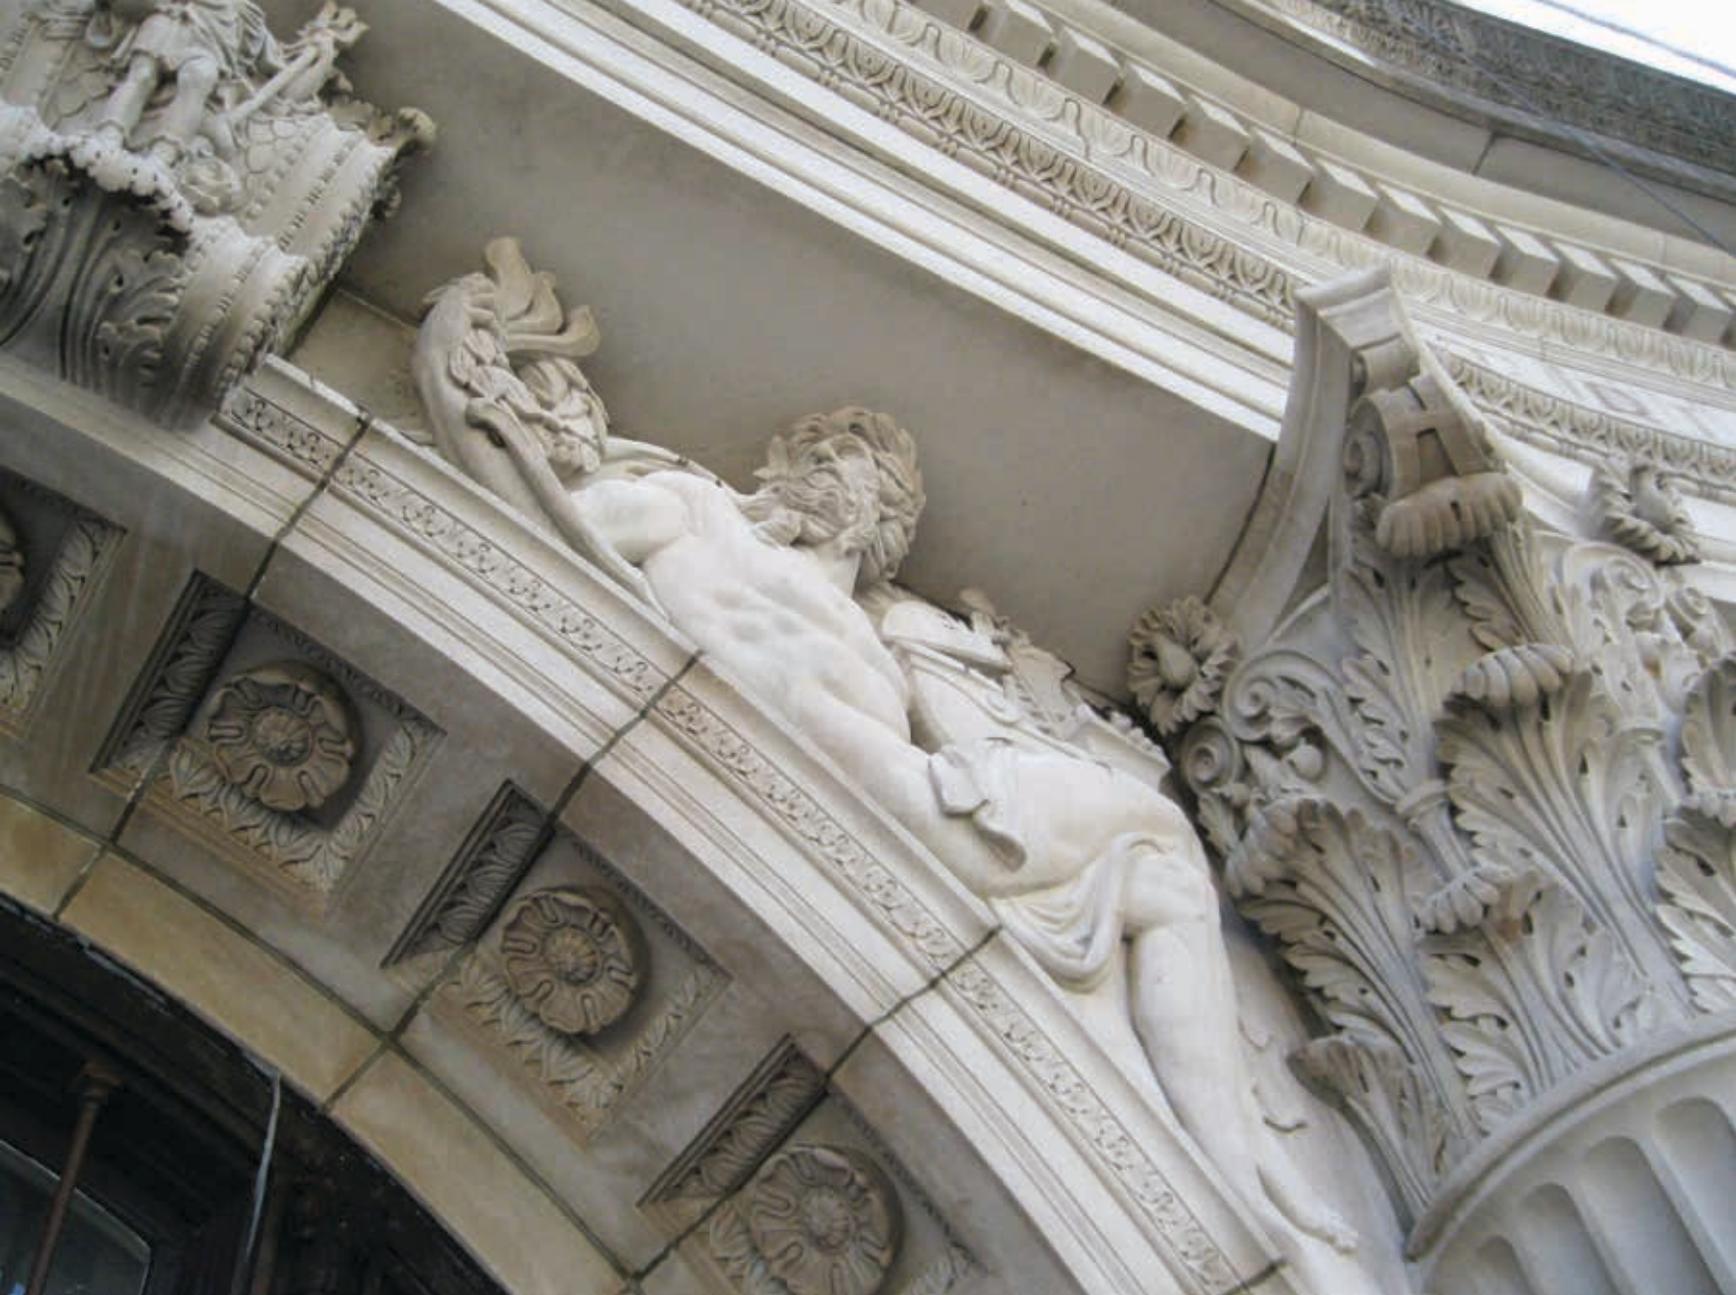
Large carved limestone colonnades, balustrades, urns, vases and griffins provide unique enrichments throughout the facades. Photo courtesy of K&H

Given the significant extent of limestone spalling and deterioration present throughout the exterior facades, a comprehensive rehabilitation program was prepared to revitalize the neglected cladding, which focused on restoring the limestone as closely as possible to its original beauty and appearance, according to Mike Naponelli, senior associate at Klein & Hoffman (K&H) in Chicago, IL.
